Radiation experience with the CMS pixel detector

Viktor Veszpremi for the CMS Collaboration^{a*}

ABSTRACT: The CMS pixel detector is the innermost component of the CMS tracker occupying the region around the centre of CMS, where the LHC beams are crossed, between 4.3 cm and 30 cm in radius and 46.5 cm along the beam axis. It operates in a high-occupancy and high-radiation environment created by particle collisions. Studies of radiation damage effects to the sensors were performed throughout the first running period of the LHC. Leakage current, depletion voltage, pixel readout thresholds, and hit finding efficiencies were monitored as functions of the increasing particle fluence. The methods and results of these measurements will be described together with their implications to detector operation as well as to performance parameters in offline hit reconstruction.

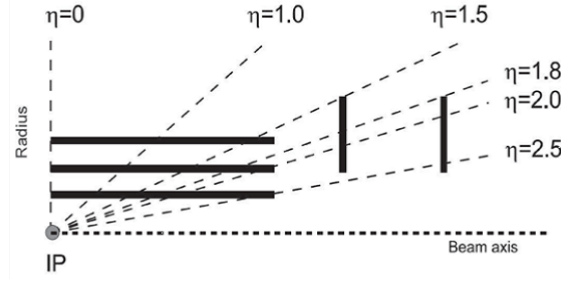
Figure 1. Quarter of a slice of the CMS pixel detector by a plane which contains its axis of symmetry. The centre of the detector is at the left-bottom corner of the drawing, in the interaction region. The horizontal axis, to which the detector has a cylindrical symmetry, is parallel to the LHC beams. The vertical axis points along the radius. Various pseudo-rapidity values are shown at the ends of the black dashed lines.

The pixel detector is the innermost component of the CMS tracker [2]. It was designed utilising a hybrid silicon technology. It comprises three layers in the barrel region at radii of 4.3 cm, 7.2 cm, and 11 cm, respectively (Figure 1). The barrel is closed at the two ends, in the endcap region, with a pair of disks at distances of ± 34.5 cm and ± 46.5 cm with respect to the interaction point, along the beam axis. Assuming a registered hit in the innermost layer (layer 1) of the barrel, this arrangement provides at least three measurement points for tracks originating from the CMS interaction region with a pseudorapidity up to $|\eta| \simeq 2.5$.

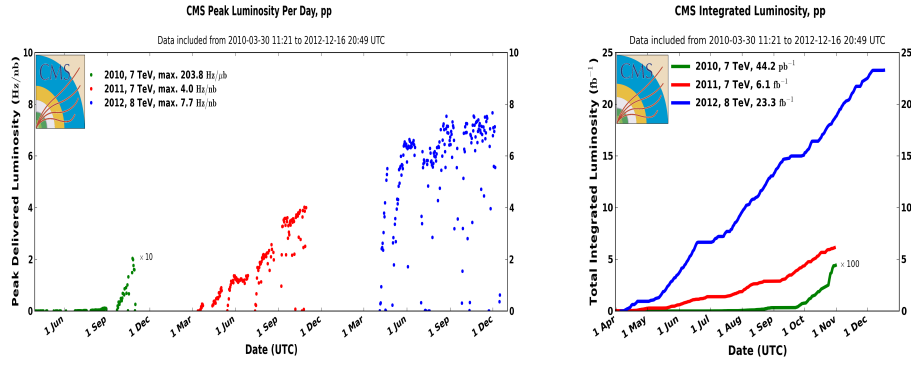
Figure 2. LHC beam parameters. Peak (left) and integrated (right) luminosities delivered to CMS during stable beams in p-p collisions as function of time. This is shown for 2010 (green), 2011 (red) and 2012 (blue) data-taking [5].

The first data-taking period of the LHC [4] between 2010 and 2013 is called Run 1. The instantaneous luminosity of the accelerator gradually improved over the years and reached its peak of $7.7 \times 10^{33} \text{cm}^{-2} \text{s}^{-1}$ in late 2012. During Run 1, the LHC delivered about 6.1 fb^{-1} integrated luminosity of proton-proton collision data at 7 TeV and about 23.3 fb^{-1} at 8 TeV (Figure 2). The charged track fluence integrated over the 30 fb^{-1} of proton-proton collision data for layer 1, 2, and 3 were $9.3 \times 10^{13} \text{ tracks/cm}^2$, $4.2 \times 10^{13} \text{ tracks/cm}^2$, and $2.1 \times 10^{13} \text{ tracks/cm}^2$, respectively, with about 20% uncertainty. The 2012 running period was interrupted by two technical stops in mid-June and mid-September. These beam-quiet periods provided the time to re-tune the calibrations of the detectors. The outcome of these calibrations are attested by most of the measurement results presented below. The inner and outer rings of the endcap disks experience a particle rate that is similar to layer 2 and 3 in the barrel. Since the highest particle fluence is measured in layer 1, we will mostly focus on measurement results obtained for the innermost layer.

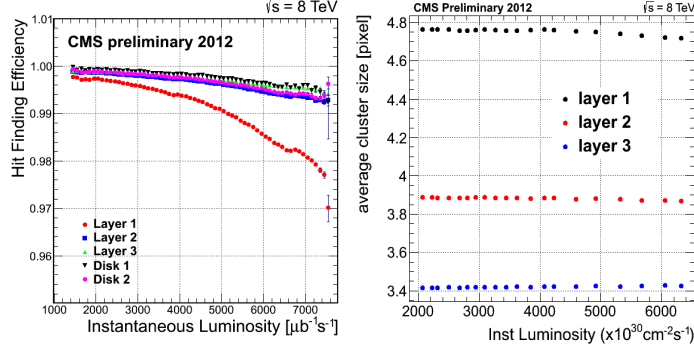
Figure 3. Cluster hit efficiency (left) and average cluster size (right) measured in various layers of the pixel detector. Chips experiencing SEUs are removed from the efficiency calculation [6].

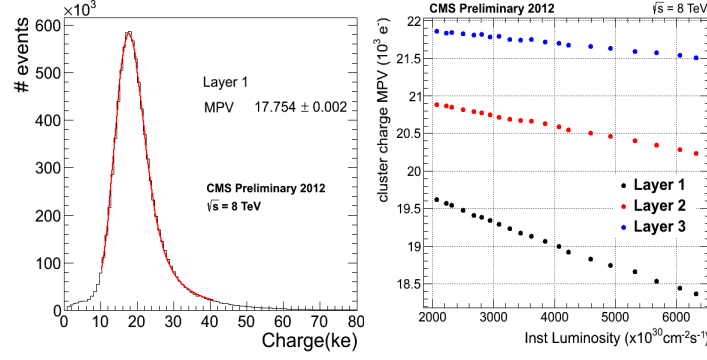
Figure 4. Cluster charge distribution normalised with the track incident angle at the end of 2012 (left) and the most probable value of its Landau fit (right) as a function of instantaneous luminosity [6] from a long LHC fill in 2012.

A high particle rate increases the power consumption of the readout chips, and therefore raises its operating temperature. The charge gain calibration was observed to be temperature dependent. Figure 4 displays a variation in the most probable value of the cluster charge as function of the

instantaneous luminosity which is more significant than it may be expected based on the variation in cluster size.

Long term variations are also observed in the cluster charge. The third plot in Figure 5 shows the most probable value of a Landau fit on the average cluster charge (see also Figure 4). Each sudden increase is due to the increased cluster size after every threshold readjustment. Each sudden drop appears after applying a new gain calibration. Since every threshold calibration is shown to restore the cluster size, the average charge should become automatically readjusted. The overall negative trend, which is observed instead, may imply a change in the gain calibration. The gain calibration associates an ADC value to an injected test charge.

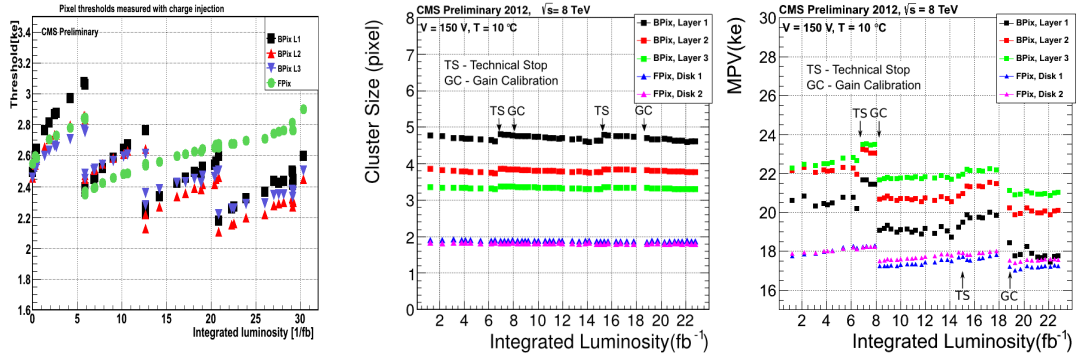
Figure 5. Plot of the pixel readout threshold (left) covering the integrated luminosity of Run 1, while data taken in 2012 starts at 6.1 fb^{-1} . The other two plots show the evolution of cluster size (middle) and the most probable value of the Landau fit of the cluster charge (right) as function of integrated luminosity in 2012 [6].

The left plot in Figure 5 shows the evolution of the pixel readout threshold. Thresholds in each layer are measured by injecting test charges into pixel cells in incremental amounts and determining the amount that corresponds to the efficiency turn-on point for half of the pixels. Discontinuities in the plot reveal when threshold readjustment took place: at the beginning of every data-taking year and during technical stops. A lower threshold leads to increased cluster size, which explains the jumps in the second plot (Figure 5), although their magnitude is inconsistent with the fact that later calibrations were observed to achieve lower thresholds. Such an effect may be possible if the

unit of the injected test charge shifts. In contrast, the gradual increase in the threshold observed between calibrations should result in diminished cluster size. While such a trend is slightly visible in the barrel layers, it does not appear in the endcap disks (FPix) where the thresholds were not readjusted in 2012 at all. The slow increase of the thresholds can, otherwise, be correlated with increased analog current measured at the power supply.

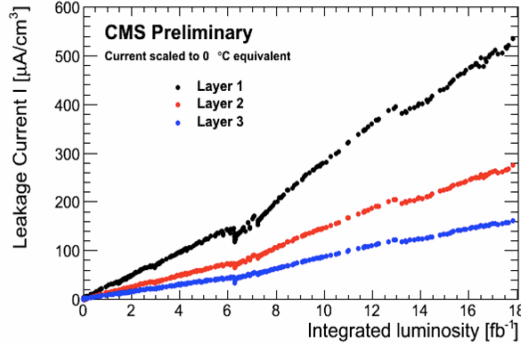
Figure 6. Leakage current scaled to 0 °C operational temperature as a function of integrated luminosity until the end of Summer 2012 [7].

Radiation damage effects induced in the silicon bulk were monitored throughout Run 1. Figure 6 shows the leakage current normalised to unit volume and temperature of 0 °C in the first 18 fb⁻¹ of this period. The leakage current increases linearly with fluence. The drop observed at 6.1 fb⁻¹ corresponds to annealing during the shutdown period between 2011 and 2012. In Run 1, the LHC beams were not perfectly centred at the CMS interaction region. The uneven particle rate produced an uneven distribution of leakage current over the azimuthal angle as shown in Figure 7 for layer 1. Each point corresponds to one of the 16 sectors that defines the surface of the barrel. On the top of a sinusoidal shape, a staggered pattern is also observed, which follows the staggered variation of the radial distance of modules in adjacent sectors. This geometry makes it possible to measure the leakage current as function of every module's distance from the interaction region also shown in Figure 7.

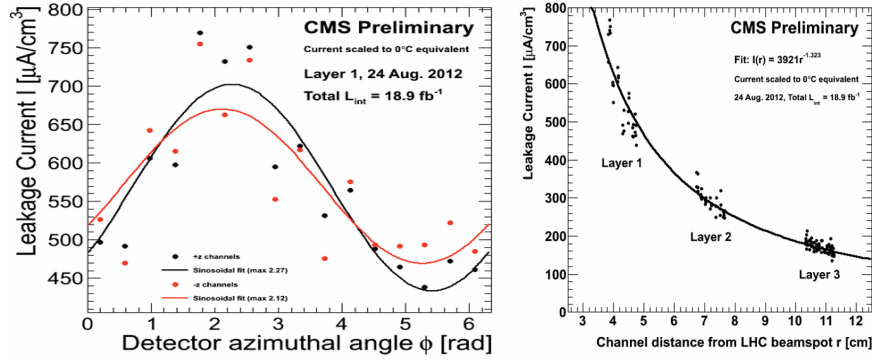
Figure 7. Leakage current scaled to 0°C operational temperature as a function of the azimuthal angle that circles around the symmetry axis of the detector (left) and as a function of the module distance from the LHC interaction region (right). The uneven leakage current in the azimuthal angle is due to an offset in the LHC beam position in the transverse plane. The data points taken in the positive and negative halves of the detector along z are fitted with sinusoidal curves [7].

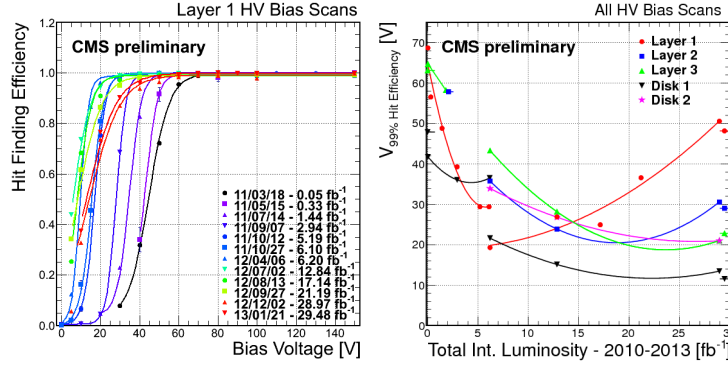
Figure 8. Bias scans performed on the pixel detector (left) and the bias voltage corresponding to 99% hit efficiency (right) as function of the integrated luminosity [6]. Multiple data points acquired in the same year are connected with quadratic fits in the right plot only in order to guide the eye, no underlying model is implied.

charge has proved to be difficult due to drifting threshold and gain calibration as described in the previous section, the data was evaluated by measuring the cluster hit efficiency. Figure 8 shows the efficiency curves as function of the applied high voltage after various amounts of irradiation. The bias voltage needed to reach a depletion depth which corresponds to the full cluster efficiency first decreases, then increases. The second plot shows the evolution of the bias voltage corresponding to 99% efficiency. Evidence of space charge sign inversion is observed in layer 1. Due to its insensitivity to cluster properties, however, this measurement cannot give account on the evolution of the charge collection efficiency when the major factor that describes radiation effects becomes charge trapping.

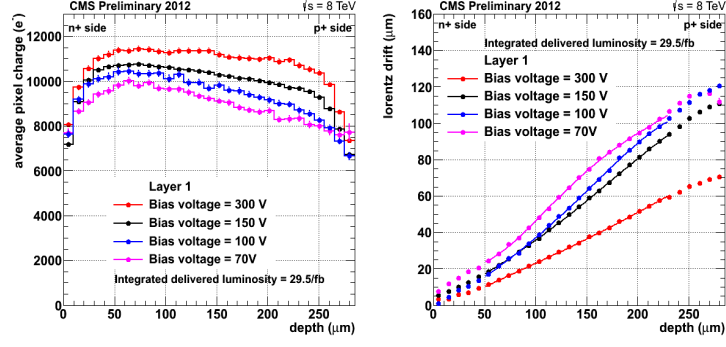
Figure 9. Charge collection profile that shows the pixel charge as function of the depth position of the charge deposit (left). Lorentz drift in the transverse plane as function of depth (right) [6].

Figure 9 shows the average pixel charge of clusters in layer 1 as function of the depth at which the charge was deposited by the traversing particles. The sensors are read out on their $n+$ side. The curves show signs of charge trapping which can be mitigated by increasing the bias voltage. The second plot shows the Lorentz drift distance of charges deposited in various depths of the sensor.

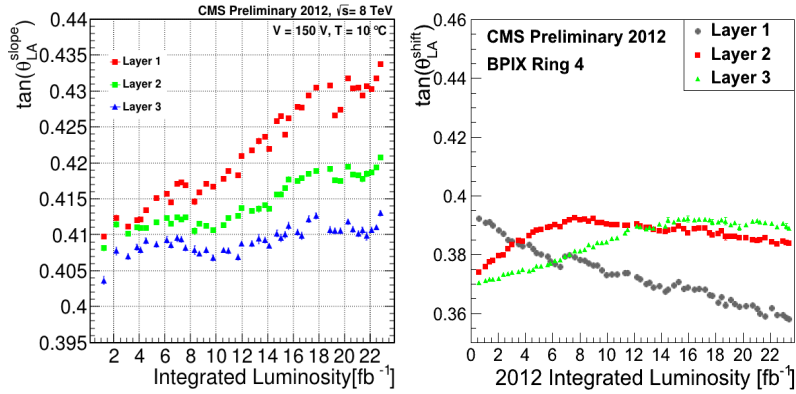
Figure 10. Lorentz angle measured near the mid-plane of the sensors (left) and Lorentz shift (right), an apparent movement of the cluster position due to the magnetic field as seen by the tracker alignment method, as function of integrated luminosity in 2012 [6, 8].

The slope of the Lorentz drift versus depth plot near the sensor mid-plane is called the Lorentz angle. Its evolution with irradiation in 2012 is shown in Figure 10. The cluster charge distribution gets wider and more tilted with higher Lorentz angle. However, this is not the only factor that influences the position measurement of a cluster. The second plot shows the shift of the reconstructed cluster position as seen by the tracker alignment algorithm. This shift is also translated into an angle. The reason why the two angles are different is currently not well understood. The value of the Lorentz shift is used as a correction on top of the Lorentz angle in the cluster position measurement algorithm in order to attain the best resolution.

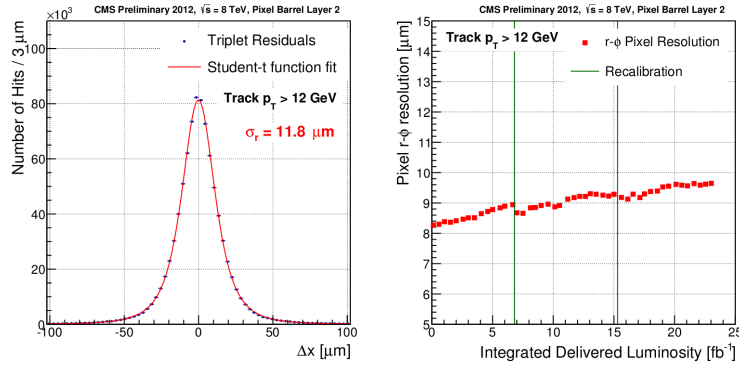
Figure 11. Triplet residual distribution for hits in layer 2 measured in the transverse plane (left) and the evolution of the corresponding resolution as a function of delivered integrated luminosity (right) [6].

The resolution of the barrel pixel is measured by re-fitting hit triplets with their reconstructed tracks whilst keeping the transverse momentum of the tracks and omitting from the fit the hit on the layer under investigation. It is derived from the distribution of the residuals between the expected and measured hit positions, shown in left plot in Figure 11 for layer 2. The measurement in layer 2 is more precise than in layer 1, since hits are used in the fit from radially adjacent layers both below and on the top of layer 2. The resolution is the width of the residual distribution after removing errors which propagate from the fit of the other two hits. Figure 11 on the right shows the resolution of layer 2 as function of integrated luminosity. Its value depends on various factors, such as the precise modelling of the charge sharing, the stability of the gain calibration, and the calibration of the readout thresholds. The re-calibrations of the thresholds which happened twice in 2012 are seen as slight improvements in the resolution.
